INFORMATION REPORT

COUNTRY	USSR (Ukrainian SSR)	REPORT NO.	25X1A
SUBJECT	Port of Odessa	DATE DISTR.	9 April 1953
	25X1A	NO. OF PAGES	4
DATE OF INFO.	25X1C	REQUIREMENT NO.	RD
PLACE ACQUIRED		REFERENCES

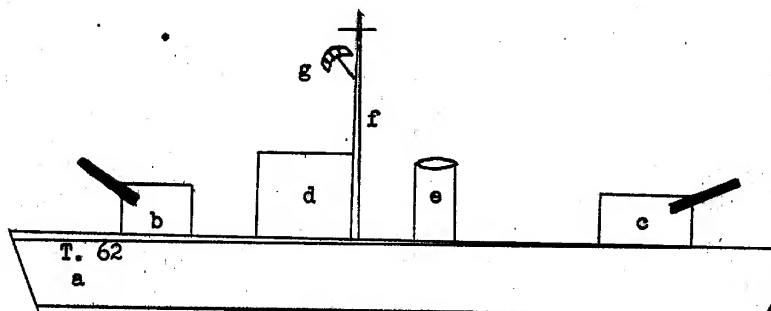
Sketch No. 1: Soviet Anti-Torpedo Boats in Odessa

2. [REDACTED] three small anti-torpedo boats. All had radar. One, marked T. 62, repeatedly left and re-entered the harbor. For a rough sketch of the silhouette of these ships see Sketch No. 1 on page 3 of this report.

- a. Markings
- b. Gun turret
- c. Square turret with one AA gun (caliber unknown)
- d. Bridge of the vessel
- e. Stack near bridge
- f. Mast
- g. Radar

25X1X (7.) The Pratique Harbor. Four or five patrol ships (auxiliary ships of the navy) were seen there, [REDACTED] The three anti-torpedo boats described in paragraph 2 above were berthed here.

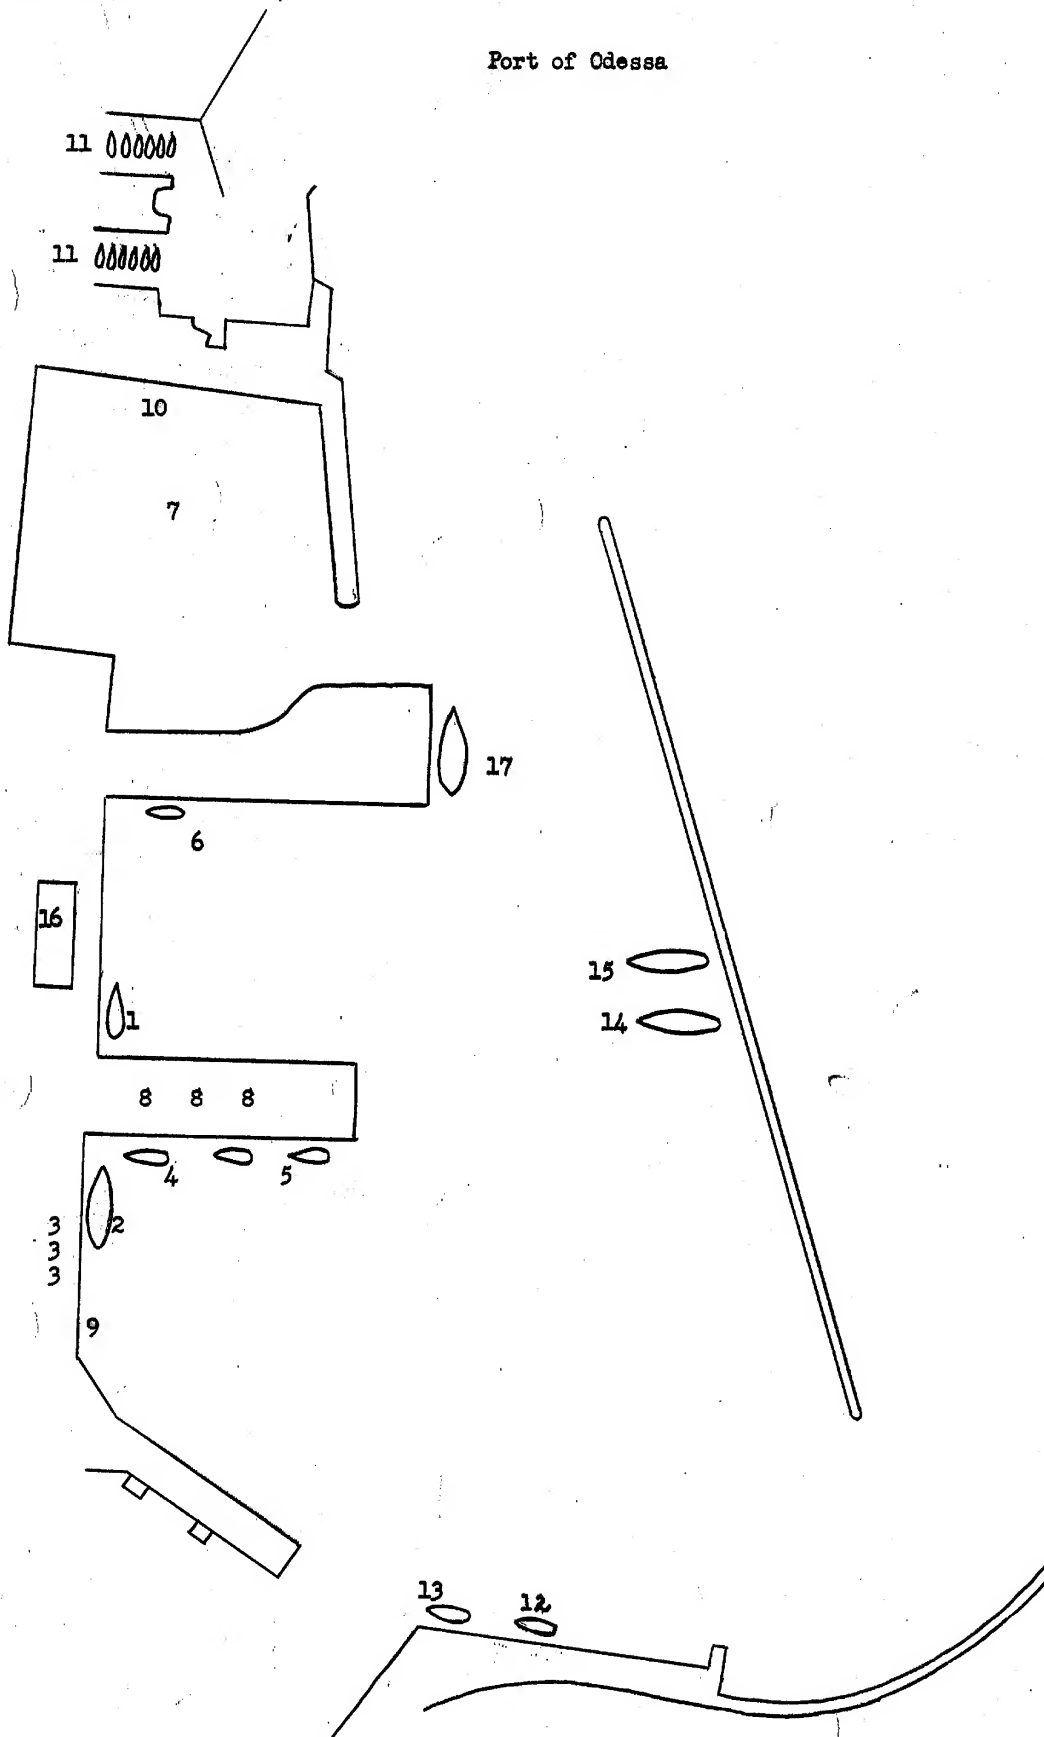
Port of Odessa

25X1X 4. [REDACTED] the weather was foggy [REDACTED] went ashore only once. The following is an explanation of the plan of the harbor of Odessa given on page 4 of this report.

(1.) Position [REDACTED] ship berthed and loaded part of her cargo of anthracite. Depth of water was up to 24 feet.

(2.) Position where the ship completed loading. Depth of water was 26-27 feet.

(3.) The storehouses indicated in the plan no longer exist. The place has been leveled and coal has been piled there in open storage.

(4.) Position of the SS LIBOV, a 1500-ton Soviet passenger ship.

(5.) Position where two dismantled Soviet ships were seen. One of them was a freighter and the other a small passenger ship.

(6.) Position where an unidentified Soviet 3000-ton freighter was loading general cargo for Japan.

- (8.) The storehouses indicated in the plan no longer exist. The place has been leveled and there are piles of coal along the entire length of the pier. There are four cranes on each side of the pier (a total of eight cranes). The cranes are electric powered, and each one has a lifting capacity of 15 tons. These are revolving cranes. The arm of each crane had "Made in England" imprinted on it.

- (9.) There are three 7-ton electric-powered cranes along this pier. These cranes move on tracks. 25X1X
- (10.) Position where a warship was seen. It resembled a cruiser, but [redacted] unable to describe it exactly because of the fog. [redacted] saw the prow of the ship as far as the single stack. There was a radar installation on the mast with an antenna shaped like that in Sketch No. 2 on page 4, located in front of the bridge and to the side. Probably there was a radar screen on each side, but informant saw only one side. There were two steel columns (of unknown use) which were wider than the mast. The stack of the vessel was tall and large and very near the prow.

- (11.) Each of two dry docks was repairing a freighter. They could not be seen clearly.
- (12.) Position where the Greek freighter RICHARD LYONS was loading grain.

- (13.) Position where a Bulgarian freighter, of about 6000 tons, was loading general cargo.
- (14.) The Greek-owned Liberty ship MONTE RAITOR (sic) was berthed at this position.

- (15.) Position where a Soviet trim, new, three-masted vessel was seen. She is used as a naval training ship. She is painted a dark color, almost black.

- (16.) This storehouse was half destroyed by the wind and is being repaired.
- (17.) Position where the GRUZIYA, a Soviet passenger ship of more than 10,000 tons, was seen.
